Army Missile Command  
Redstone Arsenal, Alabama

TECHNICAL REPORT  
RL-72-19

MIGRATION OF SILVER THROUGH GOLD PLATING  
ON ELECTRICAL CONTACTS

December 1972

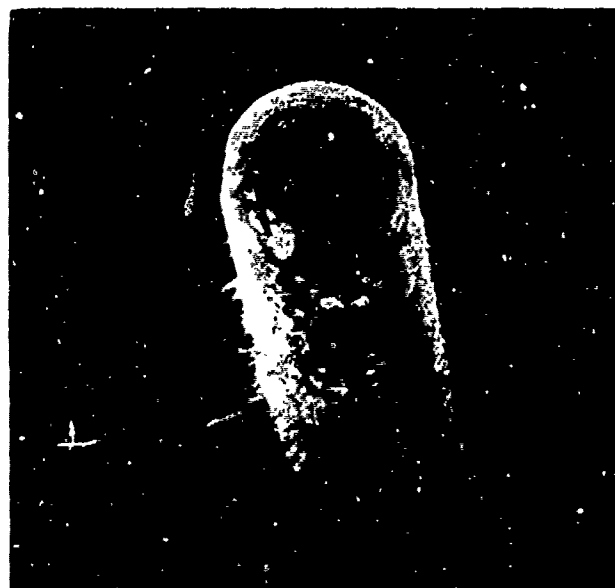
**FIGURE 10. ELECTRON MICROGRAPH  
OF A SILVER MIGRATION  
CONTAMINATED CONNECTOR PIN  
DISCLOSING THE HAIRY APPEAR-  
ANCE OF THE PROTRUSIONS.  
MAGNIFICATION 200X.**

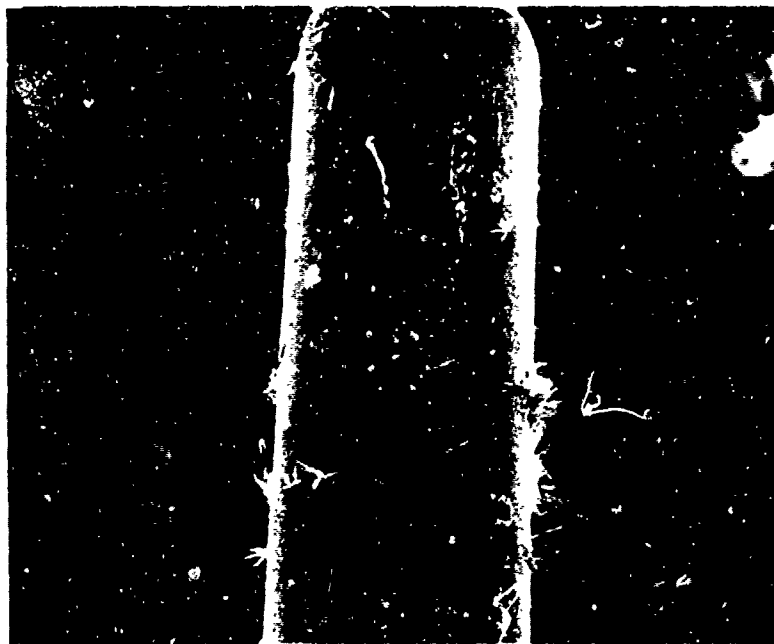
**FIGURE 49. ELECTRON MICROGRAPH. CONTAMINATED CONNECTOR PIN SHOWING THE SCATTERED MIGRATED CRYSTALS OF SILVER/SILVER SALTS, ESPECIALLY THE CATERPILLAR-LIKE PROTRUSION ON THE RIGHT SIDE. MAGNIFICATION 32X.**

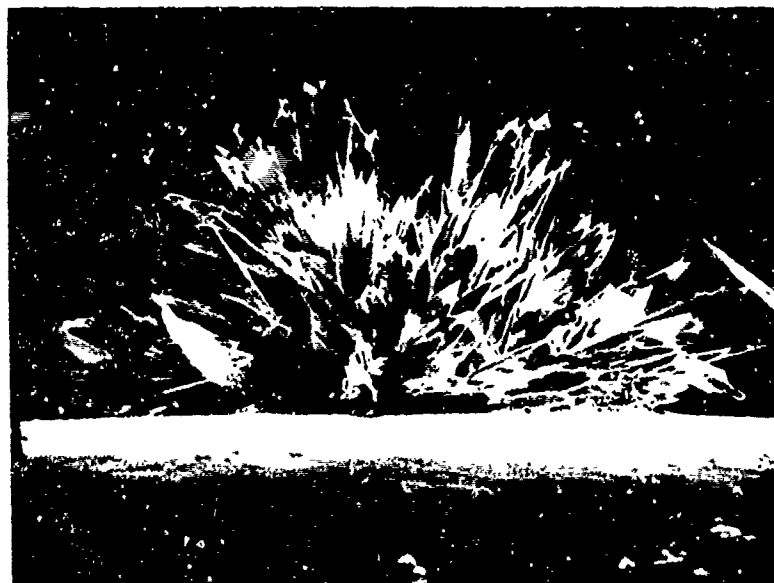
**FIGURE 50. ELECTRON MICROGRAPH. THE CATERPILLAR-LIKE GROWTH HAS TURNED INTO A FLOWER, WHEN MAGNIFIED TO 350X.**
